THE  
ECCLESIASTICAL  
ARCHITECTURE  
OF SCOTLAND

FROM THE EARLIEST CHRISTIAN TIMES TO THE  
SEVENTEENTH CENTURY

BY  
DAVID MACGIBBON AND THOMAS ROSS  
AUTHORS OF "THE CASTELLATED AND DOMESTIC ARCHITECTURE OF SCOTLAND"

VOLUME ONE

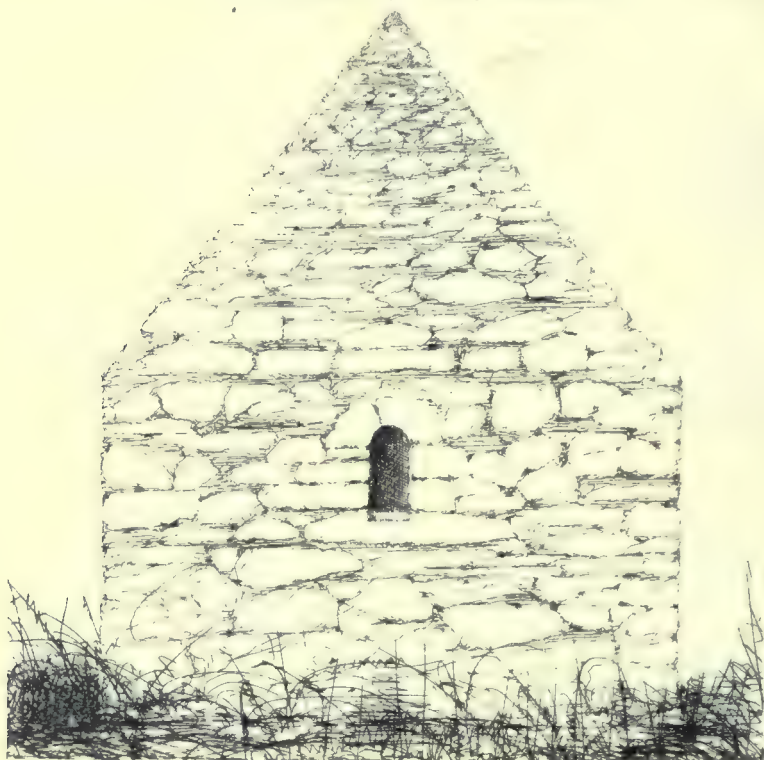
FIG. 46.—Kiels, Knapdale. Exterior East Elevation.

The church is a rudely constructed oblong, externally 42 feet in length by 21 feet in width, roofless. Windows—one close to east end of north

wall, two in south, and one with round arch in middle of east elevation. (Figs. 46, 47.) West wall blank. Windows flat except east one.\*

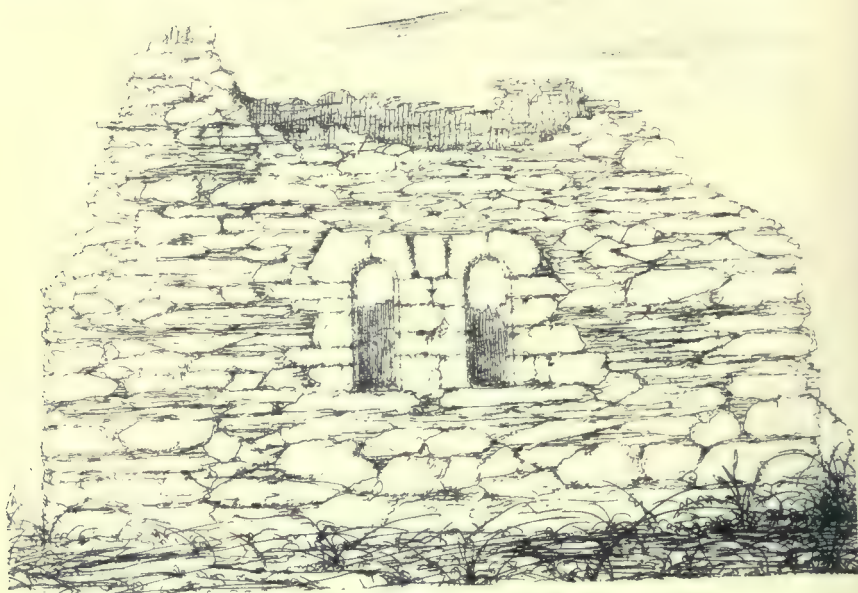
FIG. 48.—Kilmory, Knapdale. Exterior East End Elevation.

Church, rudely constructed oblong, internally 38 feet in length by 17 feet in width. Walls well preserved. Doorway near west end of south wall. Four windows; one near east end of side walls, and two together in east elevation. Side windows small rectangular apertures; east one slightly moulded and semi-circular top.† (Figs. 48, 49.)

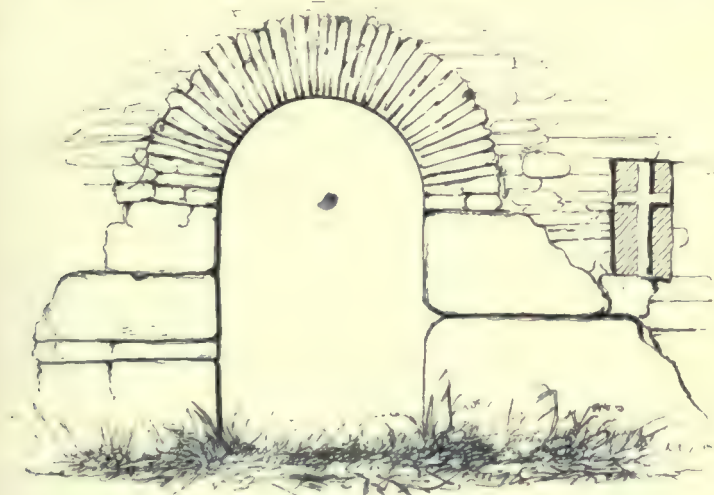
FIG. 50.—Kirkapoll, Tirée. Doorway.

KIRKAPOLL.—A very rudely-constructed chapel, internally 36 feet 9 inches long. In west end a plain round doorway (Fig. 50), 6 feet high,

rudely arched with slates, and having a small Latin cross on its south side. In south wall a round-headed door and two round-headed

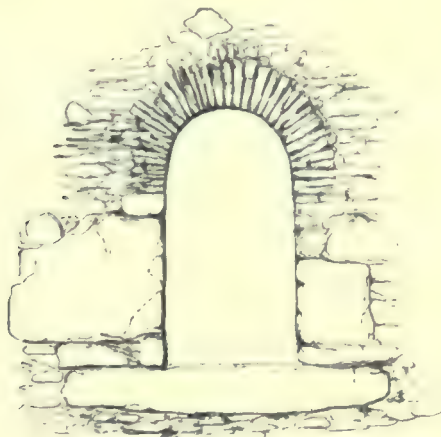
FIG. 51.—Kirkapoll, Tirée. Window.

windows, with great splay internally (Fig. 51); the north elevation blank.\*

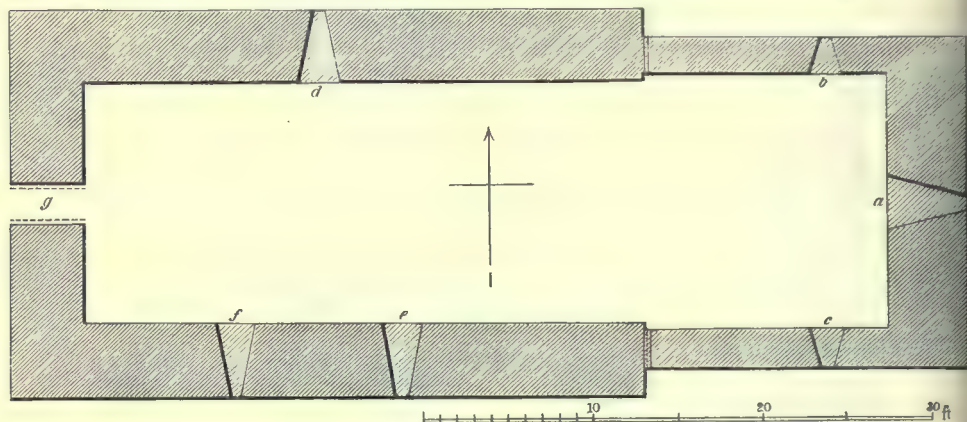
FIG. 52.—St. Columba, Balivanich. Plan.

Occupying a swampy spot, formerly the bed of a lake, are remains of a chapel probably belonging to the monks of Iona. Externally 56 feet in length and 19 feet in width. (Fig. 52.) All the windows are flat-topped and narrow; one in east end, three in south wall, and one in north wall. East wall only is perfect. ‡

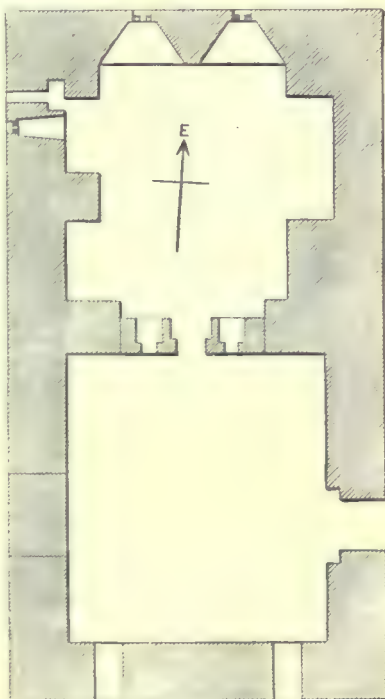
FIG. 53.

A small island lying off the Knapdale coast. "A little way up from the landing-place stands the half-roofless, though in other respects scarcely at all ruined, shell of 'Kilvicoharmaig, the Mother Church of Knapdale,' surrounded by an open and nearly obliterated burying-ground. Its external plan (Fig. 53) is a simple oblong, measuring 37 feet 5 inches in length and 20 feet in width. Internally the building is divided into chancel and nave, the division being a gabled wall open by a semi-circular arch composed of long thin slates. An apartment, which was probably a comparatively modern contrivance, appears to have gone over the nave, as there is a fireplace and chimney in the upper part of the west wall, not bearing marks of antiquity.

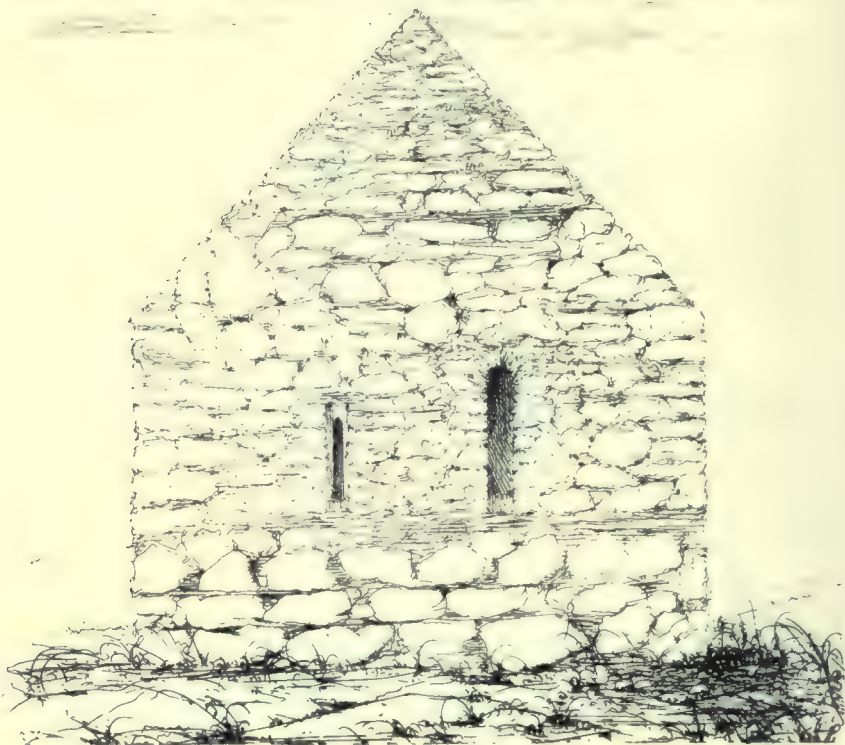
FIG. 54. -Church of St. Carraig, Eilean Mor. Exterior Elevation of East End.

"The chancel is covered by a low waggon vault, between which and the external roof there is a chamber lighted by a square window in the apex of the west gable. In the east end of the chancel (Fig. 54) are two small round-headed windows placed considerably apart, the north one, like the window at the neighbouring Kiels, having its interior sill underdrawn and levelled for an altar.

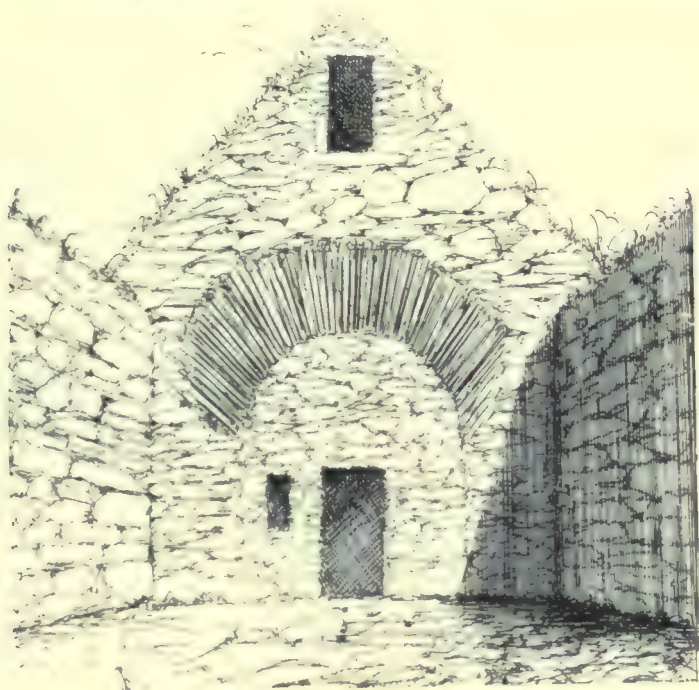
FIG. 55.— Exterior West Elevation of Chancel.

pointed, the other one trefoiled. But the most important alteration is in the chancel arch (Fig. 55), which has been lessened by blocking to a small flat-topped doorway with a square hole right through the wall on each side of it; over each of these holes, within the chancel, is an ambry of the usual square form.”

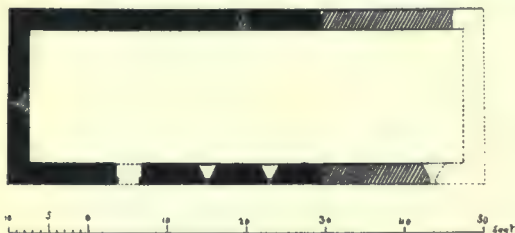
FIG. 56.—Kilchouslan. Plan.

tures square-headed. North wall blank ; seems to have been lengthened by about 20 feet ; fissure at junction similar to that at Kiels.‡

[We give Plan and View (Figs. 56, 57) of this church, originally 36 feet 7 inches long by 17 feet wide internally. The door and windows are square-

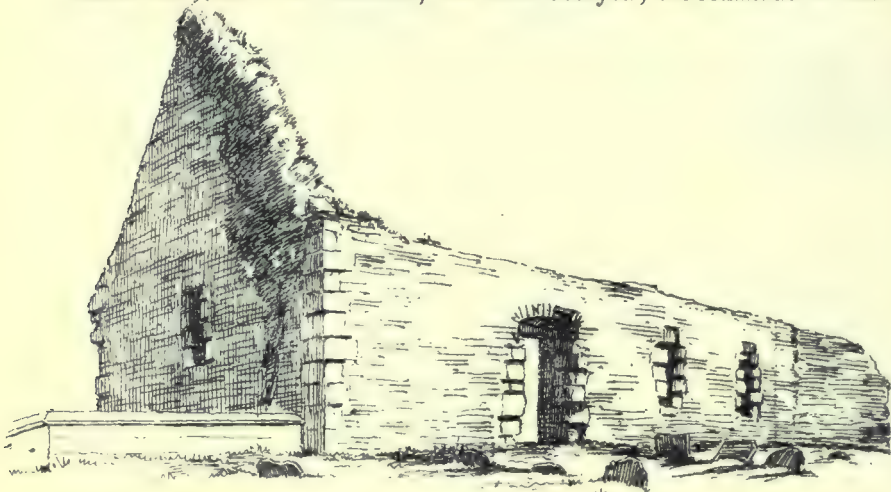
FIG. 57.—Kilchouslan. View from South-West.

headed and built with freestone, now much decayed ; the remainder of the

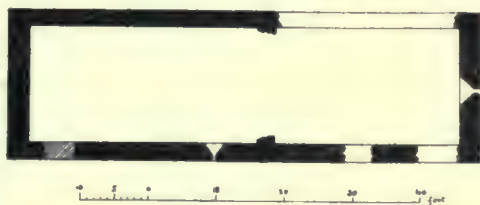
FIG. 58. — Kilchenzie. Plan.

[We also give Plan and View of this structure (Figs. 58, 59). A simple oblong church, 40 feet 11 inches long by 17 feet 3 inches wide internally, with one round-headed window, 6 inches wide, cut out of a single stone in south wall. A chancel, 27 feet 4 inches long by 17 feet 3 inches wide, has been added, of which the junction is quite apparent. One small pointed window in east end of chancel.]

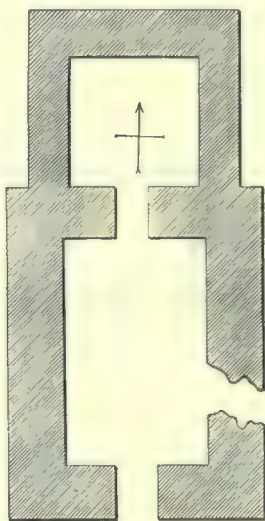
FIG. 60.—St. Mary's, Lybster. Plan.

A rudely constructed building (Fig. 60) consisting of chancel and nave. Flat-headed doorway, 3 feet 5 inches high, with inclining jambs,

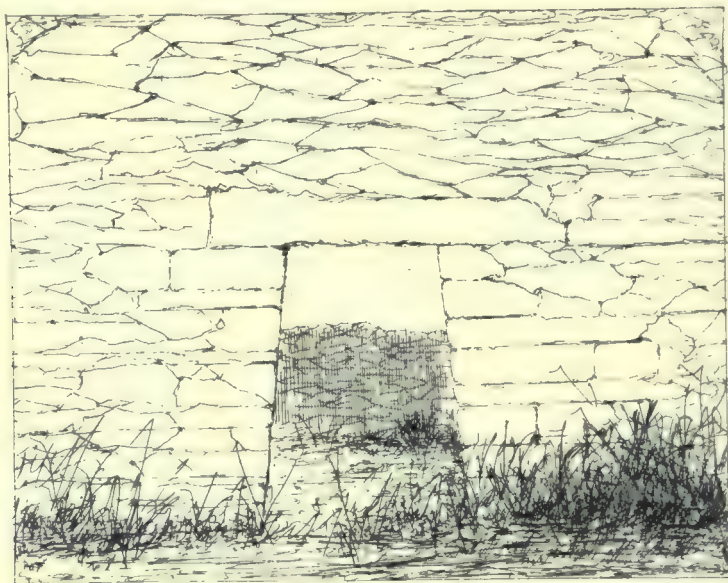
FIG. 61.—St. Mary's, Lybster. View of Doorway in West End.

in west end (Fig. 61), and possibly another door in south wall. No

windows except, perhaps, one high up in east gable. Chancel entrance same as west doorway.\*

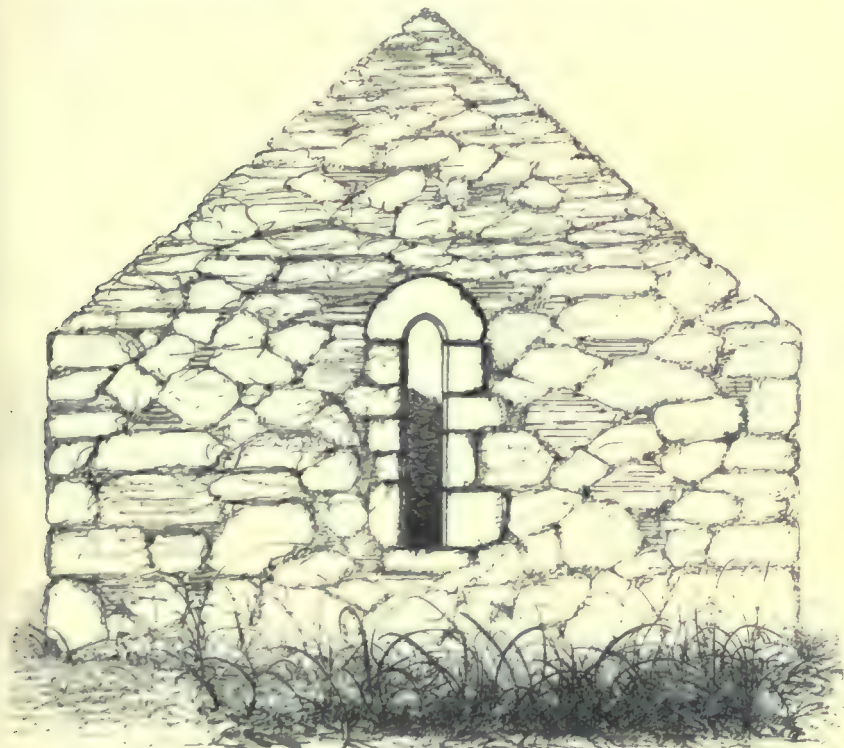
FIG. 62 — St. Catan's, Gigha. East End.

Old church, oblong, 33 feet long and 15 feet 2 inches in width. One long lanciform window in east end (Fig. 62) ; stone font. ‡

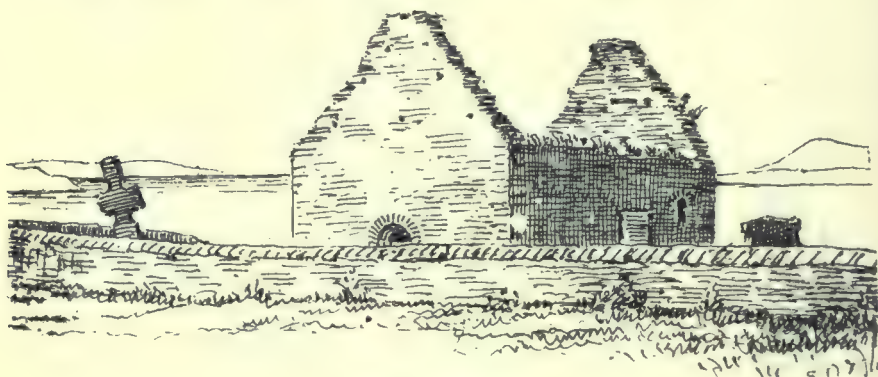
FIG. 63.—Kilneave, Islay.

Church, 30 feet long, and not very old. Two windows, short and wide—one in east elevation and one in south wall. Arches semi-circular, of thin stones. ‡ (Fig. 63.)

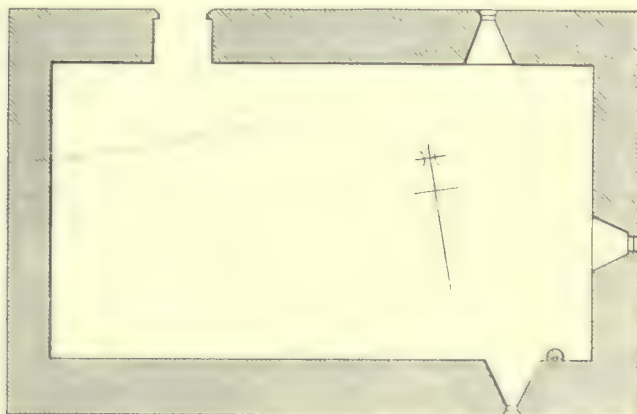
FIG. 64.—St. Ninian's, Sanda. Plan.

An island off the east coast of the Mull of Cantyre. The church is an oblong, 32 feet 9 inches. (Fig. 64.) Walls pretty entire. Doorway

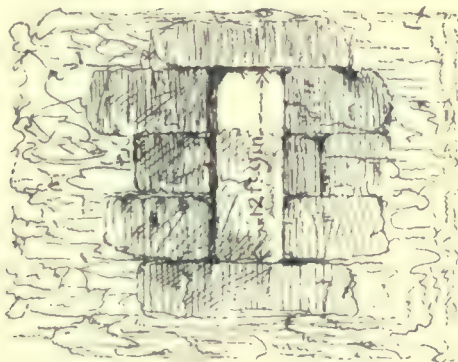
FIG. 65.—St. Ninian's, Sanda. South-East Window.

plain, chamfered, and flat-headed, at north-west. Windows small and flat-headed. (Fig. 65.) Small circular piscina. Lying inside, bowl of font.\*

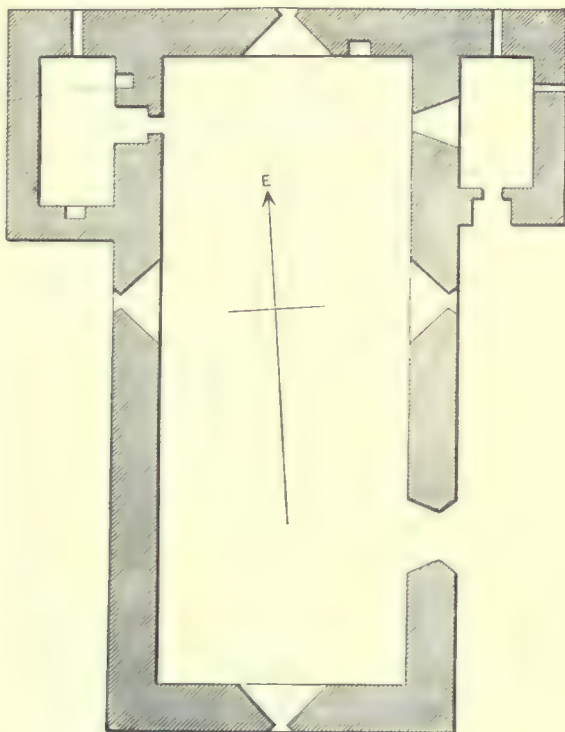
FIG. 66.—Teampull Eorrapidh, Lewis. Plan.

Teampull Moluach. Simple oblong; internally 44 feet long by 17 feet 9 inches wide, with north-east sacristy and south-east chapel, both roofed with lean-to. (Fig. 66.) Doorway at south-west, semi-arched;

east window round head, rear arch pointed; west window smaller, round head with round rear arch. At top of east and of side walls two small square windows close together, and to west one large and round-headed of one stone. Windows in side buildings mere slits, flat in head.\*

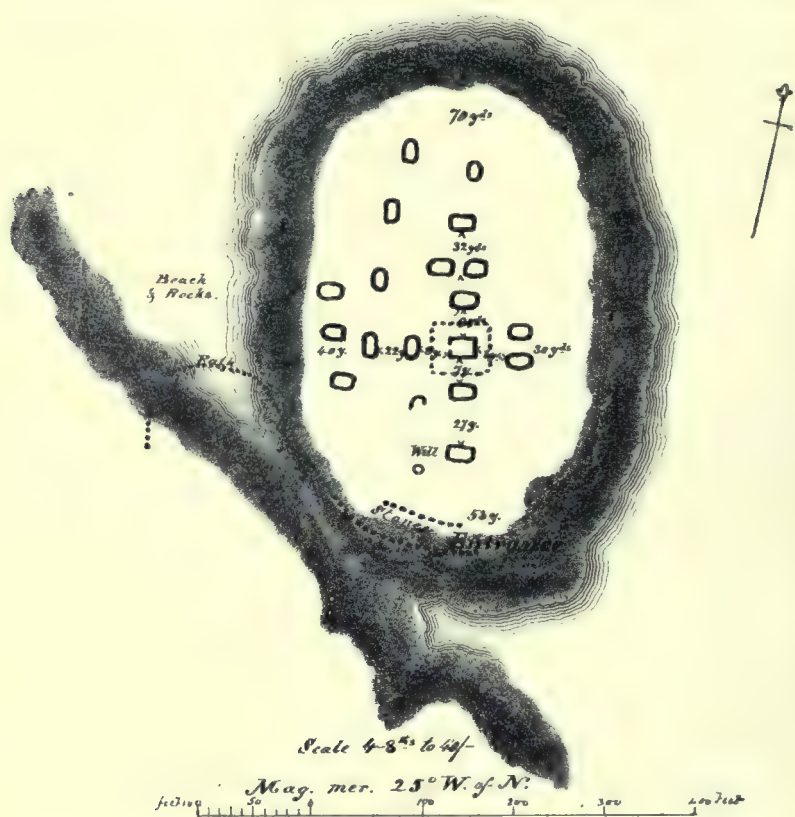
FIG. 68.—Brough of Deerness.

The chapel (Fig. 70) is near the centre of the brough, enclosed in a yard 57 feet by 45 feet, of which only the foundation remains. The

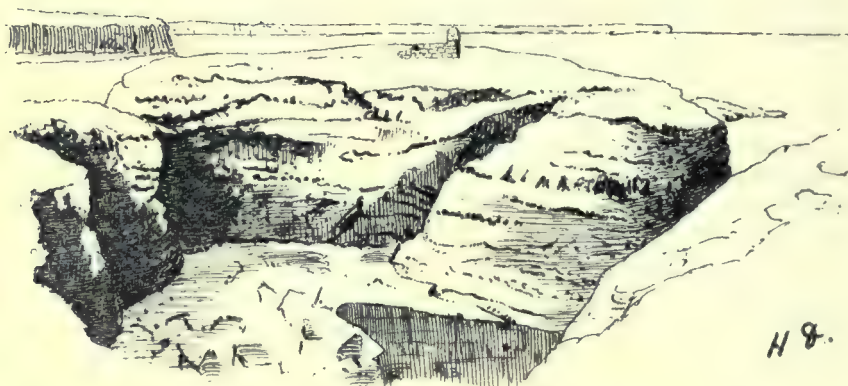
FIG. 69.—Chapel on Brough of Deerness.

The brough is highest on the north, and at that part is about 90 or 100 feet high. (Fig. 69.) The coast hereabouts is steep and rocky. The use of the word *brough* for a detached rock, when *no fort* is placed on it, is not unfrequent.

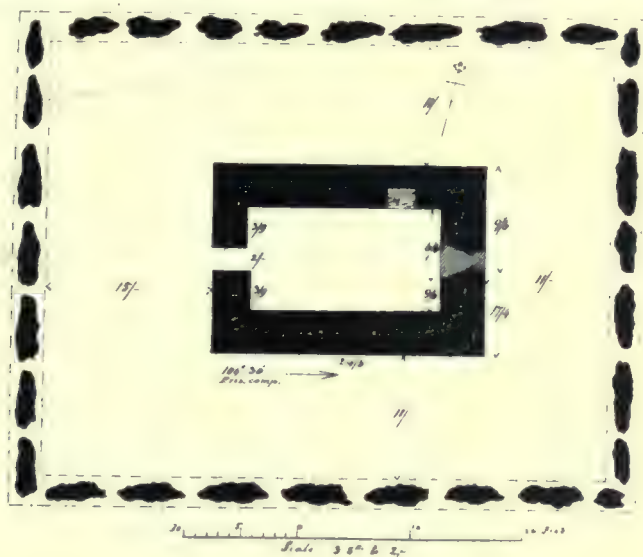
FIG. 70.—Chapel on Brough of Deerness. Plan.

entrance into this is not evident. The chapel is a parallelogram, 24 feet 5 inches by 17 feet 4 inches outside. The west wall is 3 feet 2 inches, and the others 3 feet 11 inches thick. Only about 4 feet 6 inches and 5 feet in height remain above ground. It stands nearly true east and west, the west end facing a little south of west. It is built of clay slate from 1 foot to 3 feet long, and 2 to 7 inches thick, now much covered with yellow lichen. It has only one doorway (Fig. 71), which is in the west

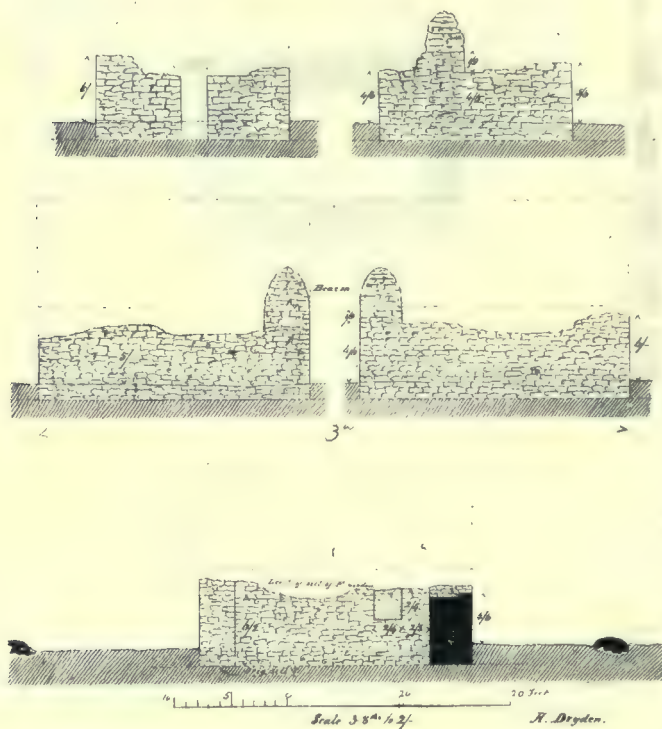
FIG. 71.—Chapel on Brough of Deerness. Elevations.

end, and apparently was only 2 feet wide ; but the west wall is irregular, and appears to have been altered and repaired. The upper part of the doorway is gone, but probably it was square headed, with a stone lintel. The jambs are not splayed, and have no rebate for a door, nor is there any bar hole.\* By digging at the west doorway it appeared probable that the floor inside was about 6 feet below top of sill of east window, but the level is uncertain, as the interior is much covered with debris.

Apparently there was only one window, which is in the east end. (See Fig. 71.) The top is gone, so that it is doubtful whether it was flat or arched. One jamb is gone and the other somewhat mutilated, but 1 foot 9 inches in height of it remains. The window had a clear opening of 1 foot 3 inches, with jambs splayed inside, to 3 feet 6 inches in width. It appears to have had the outer 11 inches of the jambs parallel, and to have contained glass. On a part of the east wall is built a beacon used for the survey.

In the north wall, near east end, is an ambry 2 feet 4 inches wide, not less than 2 feet 4 inches high (top is gone), and 1 foot 11 inches recessed. It has no traces of having had a door.\* Supposing the floor to have been 6 feet below sill of east window, probably the side walls were about 8 feet high, and the points of the gables about 18 feet from floor. The roof was probably of large slabs of stone along the eaves and above them, either of smaller slabs or of "divots," fastened down with "simmons" as on houses.

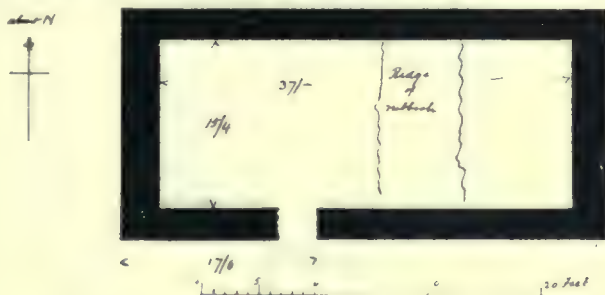
FIG. 72. — Chapel near Shore of Head of Holland. Plan.

This is situated within a few yards of the shore, and not many feet above water level. It is only a heap of ruins, but the measures are just ascertainable. It is a parallelogram, measuring 37 feet east and west by

15 feet 4 inches north and south inside. The north and south walls are 2 feet 6 inches thick, and east and west ends 3 feet 3 inches, and are of the red sandstone of the locality. There was a door in the south wall. Planned in 1870. (Fig. 72.)

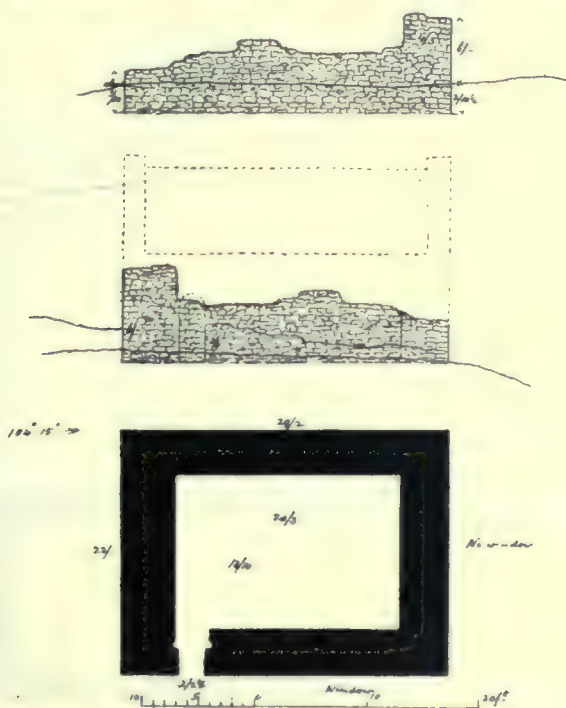
FIG. 75.—St. Tredwell's Chapel. Plan and Elevations.

be obtained from the Saint by her devotees. It is a plain parallelogram (Fig. 75), 20 feet 3 inches east and west by 13 feet 10 inches north and south inside, and stands west by south and east by north. There is a narrow doorway near the west end of the south side. Only the lower portions of the walls remain, except at north-west angle, which measures 8 feet high; but here we have, as usual, the unfortunate information that within memory the east gable and south wall were standing. The thickness of the wall on the north is 3 feet 11 inches; east, 4 feet 2 inches; south, 4 feet 3 inches; and west, 4 feet 9 inches. It is stated that there was a window in the east end, and that the doorway was flat headed. No trace of a window remains, and only about 3 feet 6 inches of the door jambs remain. These have a rebate into which a door is fitted, but whether in a wooden frame or not cannot be ascertained. The original floor appears to have been 10 feet above water level.

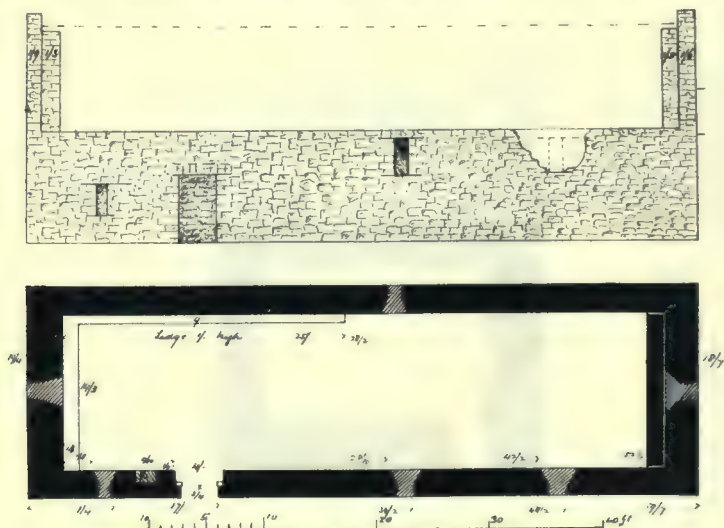
FIG. 76.—Chapel near Westness, Rousay. Plan and Elevation.

This is in a graveyard, close to the west shore of Rousay, about a mile north of Westness. It consists of a long parallelogram, and, but for a stoup near the door, and apparently an ambry near the east end, might be taken for a post-Reformation building. It has been used till within memory. It stands about east and west. (Fig. 76.) It is 52 feet 11

inches east and west by 14 feet 5 inches north and south inside; and the walls are 2 feet 6 inches on north and south, 2 feet 11 inches on east, and 3 feet 8 inches on the west. It is now roofless, and in some parts broken. From the floor to the top of side walls is 9 feet 10 inches.

There is one doorway near the west end of south wall. (See Fig. 76.) This is flat headed and rebated, measuring 3 feet 4 inches clear width. To the west of this doorway and low down is a window 2 feet 11 inches by 1 foot 4 inches clear, flat headed, and splayed inwards and outwards. Between the window and the doorway (inside) is a recess, probably for holy water. To the east of the doorway is a window 3 feet 3½ inches by 1 foot 4 inches, flat headed, and splayed as before. The head is nearly as high as the eaves. Farther east is another similar window. About midway along the north wall is a window 2 feet 1½ inch by 1 foot, clear

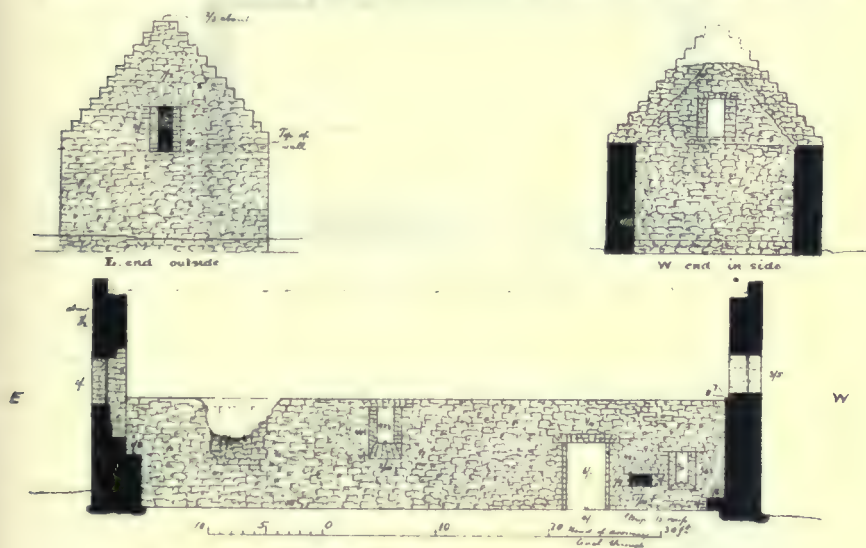
FIG. 77.—Chapel near Westness, Rousay. Sections and Elevation.

opening, flat headed, and splayed as before. The head is nearly as high as the eaves. In the east end (Fig. 77) is a window, of which the sill is nearly as high as the eaves, 4 feet by 1 foot 2 inches, clear opening, with flat head, and splays in and out; under this window, and across the end inside, is a sort of shelf at the height of the top of the altar. In the west end is a

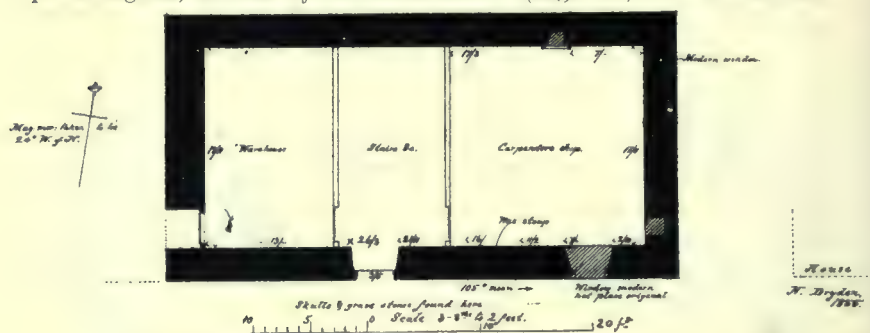
FIG. 78.—St. Ola, Kirkwall. Plan.

It stands about west by south and east by north. It consists of one parallelogram, 35 feet by 18 feet inside. (Fig. 78.) The south side

The south wall is 2 feet 11 inches thick, the west 3 feet 6 inches.

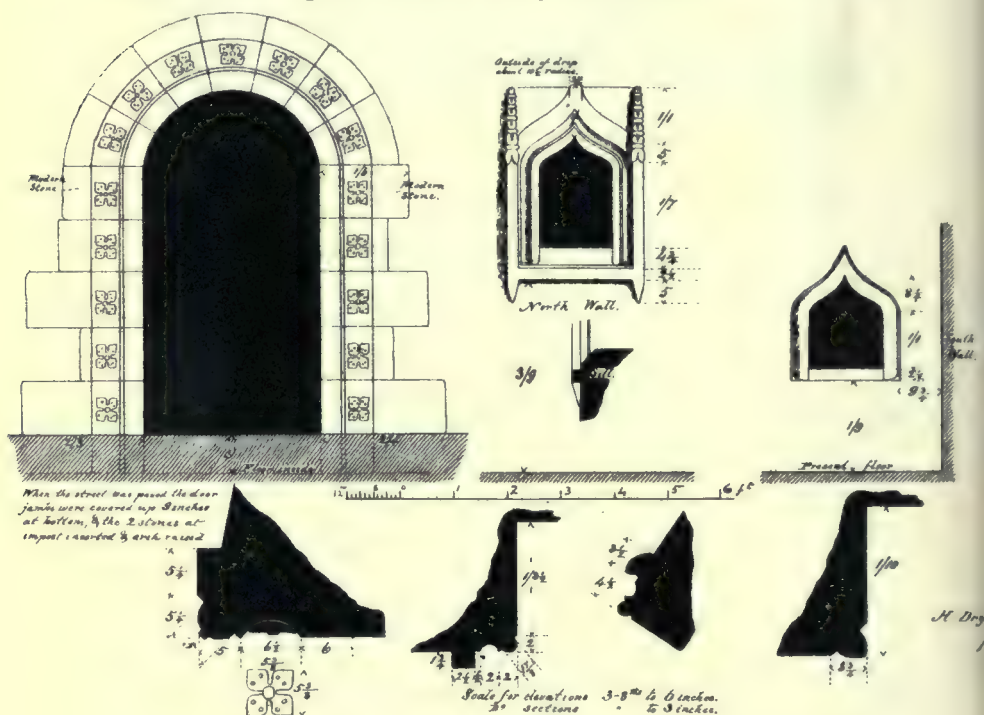
FIG. 79.—St. Ola, Kirkwall. Details.

The original entrance is on the south, 17 feet from the exterior west angle. (Fig. 79.) It is 3 feet 5 inches wide, with a semicircular head and continuous mouldings of a hollow, ornamented with four-leaved flowers and a filleted roll, like many of the mouldings in the cathedral, except as to the flowers. When the street was paved about thirty years ago the ground was raised, the jambs were covered up 9 inches, two stones were inserted just below the impost and the arch raised. What the height of the side walls was is not now evident. They are now about 20 feet above the original floor at the entrance. Probably the ridge was about 24 feet high.

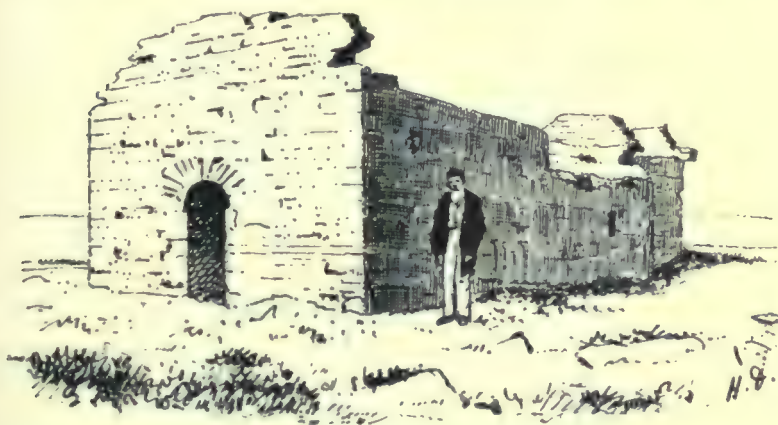
FIG. 80.—Church, Wyre, Orkney. From South-West.

This stands on a flat piece of ground about the middle of the island, in a walled burial-ground, still used. The chapel has no roof, and is much filled up with rubbish. Large parts of the south wall have tumbled, as well as smaller portions of other walls. (Fig. 80.)

It is built of grey whinstone, without any freestone dressings. The stones average about 1 foot 6 inches long by about 5 inches thick. It

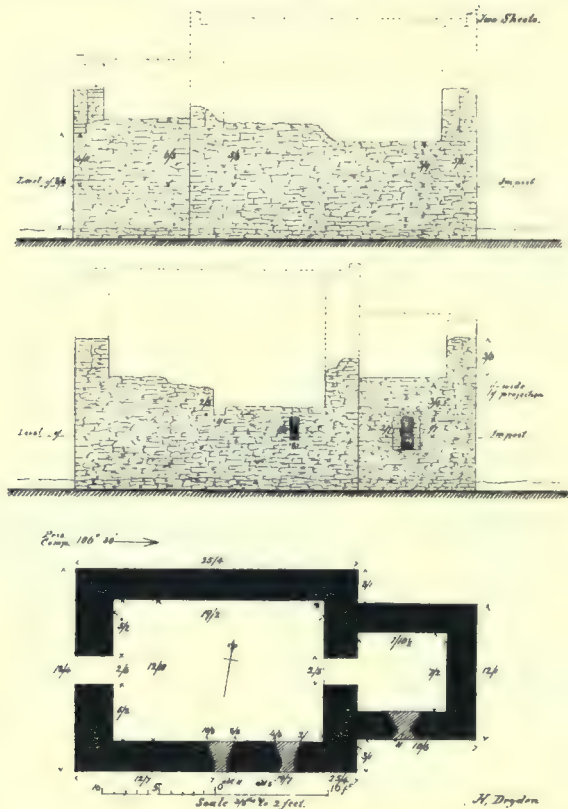
FIG. 81.—Church, Wyre, Orkney. Plan and North and South Elevations.

There are no windows on the north or west of the nave. There are two on the south side, but only one of these appears original. This has a

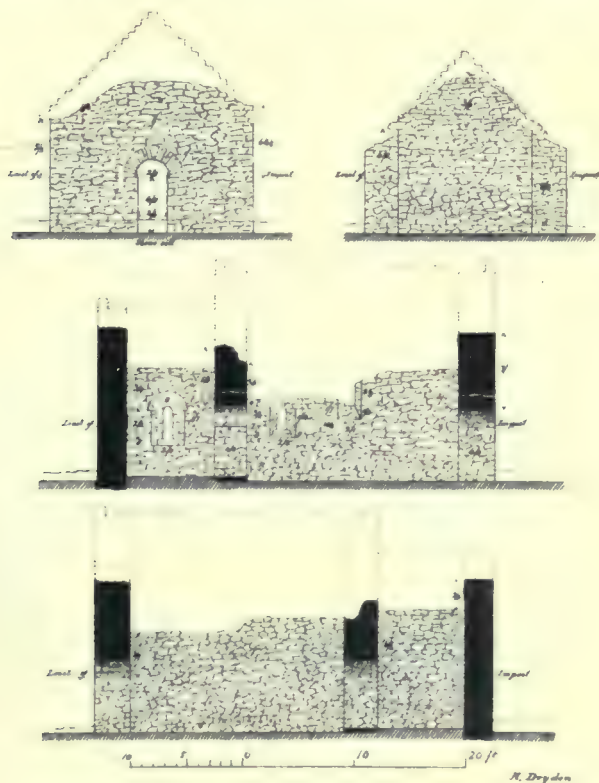
FIG. 82.—Church, Wyre, Orkney. Sections and East and West Elevations.

There is one window on the south which appears to have been round headed, and 2 feet 7 inches by 11 inches. The jambs splay inward to

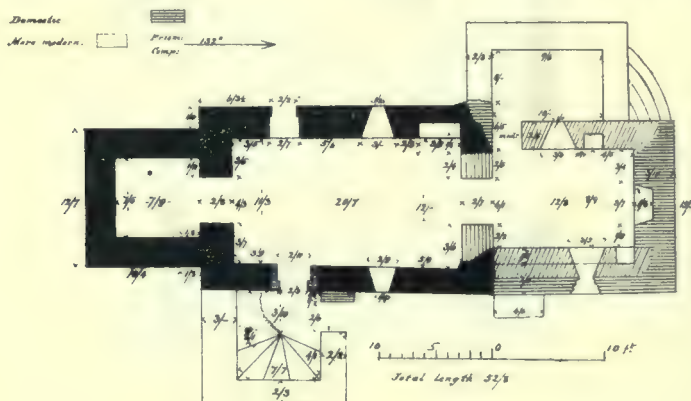
FIG. 83.—Church, Enhallow, Orkney. Plan.

It is of grey whinstones, mostly from 1 foot to 2 feet long (average 1 foot 6 inches), and 6 inches to 2 inches thick. The exterior length is 52 feet 8 inches, and the extreme width 23 feet 4 inches. It stands nearly exactly east and west. (Fig. 83.) The nave is 20 feet 7 inches by 12 feet

The chancel is 12 feet 8 inches by 8 feet 9 inches inside, set out symmetrically with the nave. (See Fig. 83.) When it was made domestic a doorway was cut in the north wall. For some reason the upper part of the south wall was pulled down, and a casing put *outside* the lower part. A fireplace and chimney were made in the east wall, and a new face put outside the whole east end, including the added piece on the south, for no break or juncture is visible outside the east end. On the north is one window 2 feet by 1 foot clear, with splayed jambs, but no freestone dressings, and no external chamfer.\* To the east of it is a small ambry. The window and ambry on the north are on a higher level than on the south.

Outside the south door of nave is a square addition, measuring 8 feet 1 inch by 7 feet 7 inches inside, now only 6 feet high, containing a radiating stair of five freestone steps. (See Fig. 83.) The west wall of it is 3 feet, and the south and east 2 feet 3 inches. There is no evidence of what this was, or led to, but the building certainly is ecclesiastical by the character of the work. The entrance to it from outside is on the east. Perhaps the stair led to a priest's room or parvise over the porch, which, however, must have been very small; or it led to a bell turret. There are several jamb stones of red freestone belonging to a doorway lying about, and one (apparently in its proper position) is in the jamb of the outer entrance of this porch. (Fig. 88.) This makes it probable that this building is cotemporary with chancel arch. The red freestone window jambs, above mentioned, may have come out of this porch. Whatever the upper part of this porch was, the roof must have been higher than the eaves of the nave.

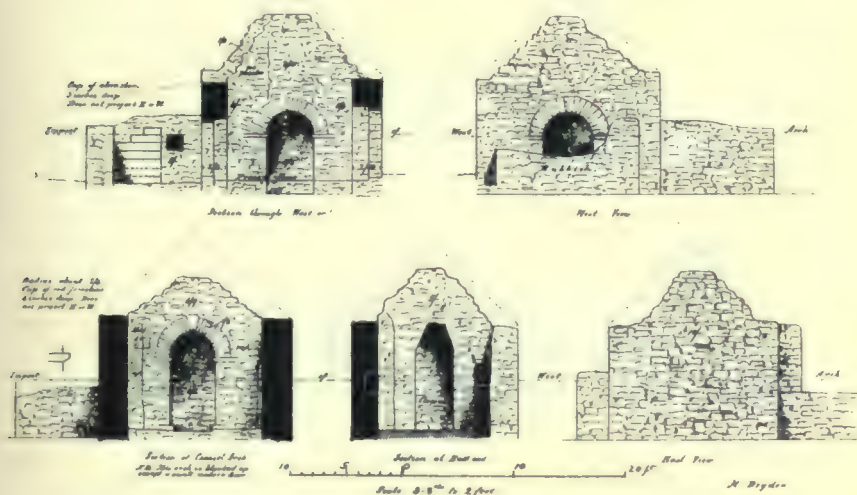
FIG. 84.—Church, Enhalow, Orkney. Sections and East Elevation.

inside. On the west of this, and entered through a round-headed arch, 4 feet 3 inches wide, with parallel jambs 2 feet 8 inches thick, is a building 7 feet 9 inches and 7 feet 5 inches inside, with walls 2 feet 7 inches thick, without any doorway to the outside, and with only one small square window to the south, perhaps not original. It is in the position of a tower, but it is not likely that a tower of that size would have been added to so small a church, and the walls are too thin. The size and character of the arch into it (Fig. 84) are against the notion that it was a

It is not certain whether the present chancel on the east is cotemporary with the nave, or whether there was an earlier one or none; but the present chancel arch is clearly an addition of a much later date than the nave. (See Fig. 84.) It is 4 feet 1 inch wide, pointed, has red freestone caps chamfered, and the mark of insertion is clear on the north side of it. It will be seen that the nave is 11 feet 3 inches wide at west end, and 12 feet at east, and in the south-east corner there is a slight projection and roughness. This may be the junction of a former south wall of the nave which got out of repair, or it may be the junction of the jamb of the chancel arch. When the chapel came to be used for a cottage it was divided into two stories. (Fig. 86.)

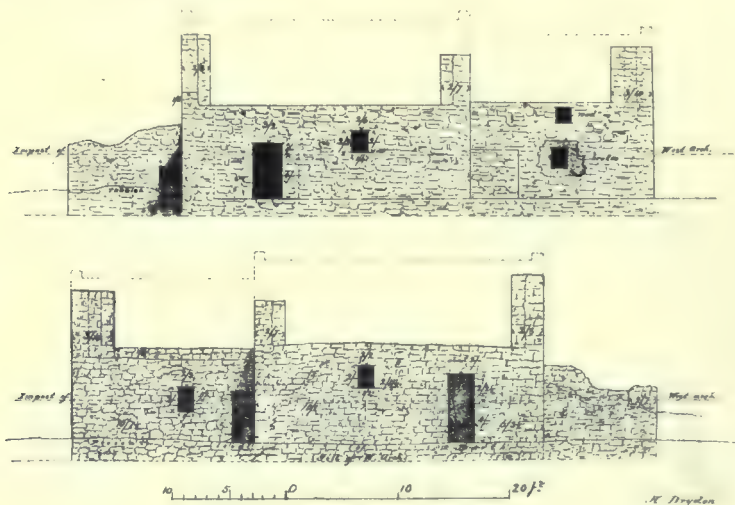
FIG. 85.—Church, Enghallow, Orkney. North and South Elevations.

The heads are square. (Fig. 85.) Probably at the beginning of the domestic period the south one was altered in some degree, and the north one made or altered. If the building at the west end was the original chancel, these entrances are not cotemporary with *that*, being in wrong position for that arrangement.

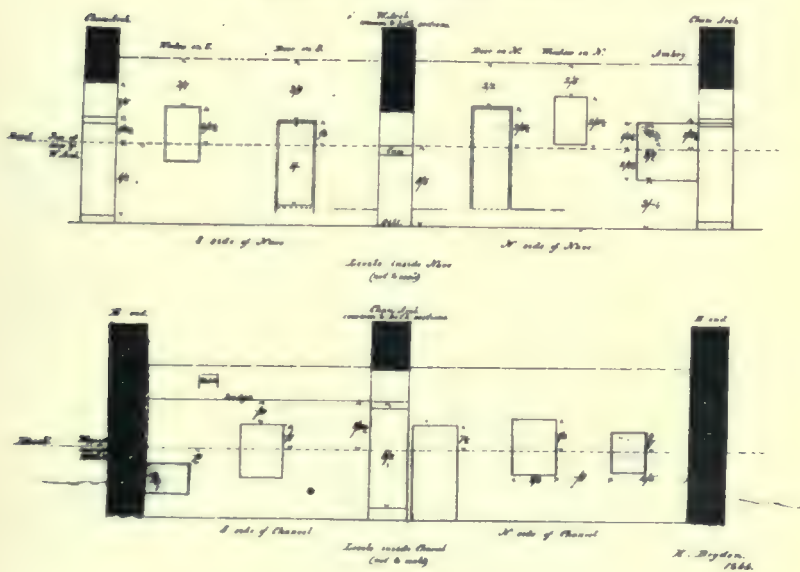
FIG. 87.—Church, Enhallow, Orkney. Sections.

On the north (Fig. 87) is one window, square headed, 2 feet by 1 foot 2 inches clear, with splayed jambs, but without freestone dressings or external chamfer, and in north-east corner is an ambry 3 feet 9 inches by 3 feet 9 inches, and 1 foot 6 inches recess. The bottom is 3 feet 6 inches above the original floor. The position is peculiar.

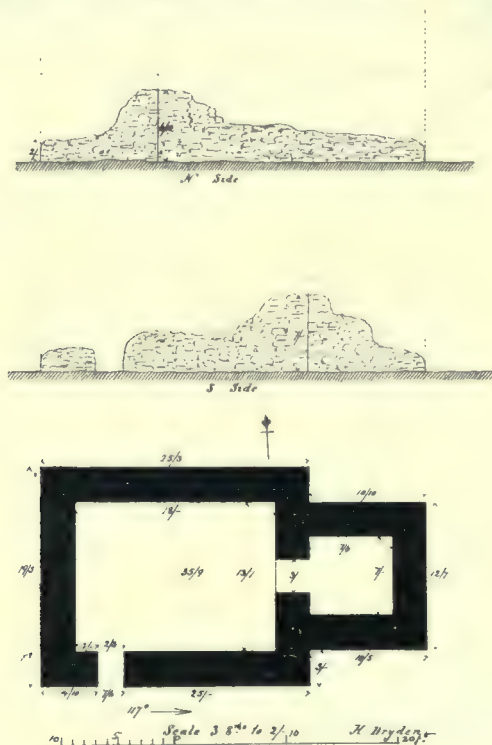
FIG. 90.—Linton Chapel. Plan and Elevations.

This chapel is near the shore at the south-east part of the island. It consists of nave and chancel, and stands nearly exactly east and west. (Fig. 90.) The extreme length is 35 feet 9 inches, and the width 19 feet

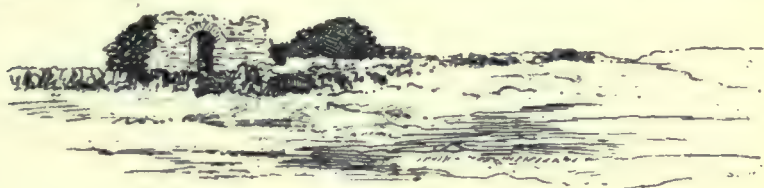
FIG. 91.—Linton Chapel. View.

5 inches. About 7 feet in height of the east end of the nave, including the arch into the chancel (Fig. 91), remains; but of the rest only about

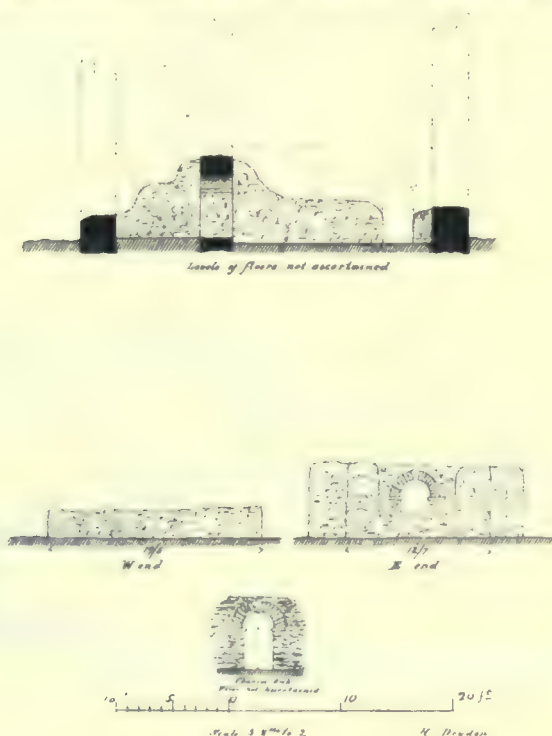
FIG. 92.—Linton Chapel. Section and Elevations.

The entrance is in the south wall near the west angle, differing in this point from most of the early chapels, and is 2 feet 8 inches wide with parallel unrebated jambs.\* The upper part of the entrance is gone, but probably it was a semicircular arch. (Fig. 92.) Nothing can be stated

of the windows. The chancel arch (see Fig. 92) is semicircular, of rough stone, 3 feet wide, with plain parallel jambs, and the arch is set back on the jambs at the impost, which is about 5 feet 6 inches high from the supposed floor of the nave. The inside is much filled with rubbish. It is uncertain whether there was a step at the chancel arch. The chancel is 7 feet 6 inches by 7 feet inside, narrower than the nave by the thickness of the walls. The north and south walls are 2 feet 10 inches thick, and the east wall 3 feet 4 inches. Only about 2 feet in height of the east gable remains, though within the memory of man the east gable was standing and a cross on it.

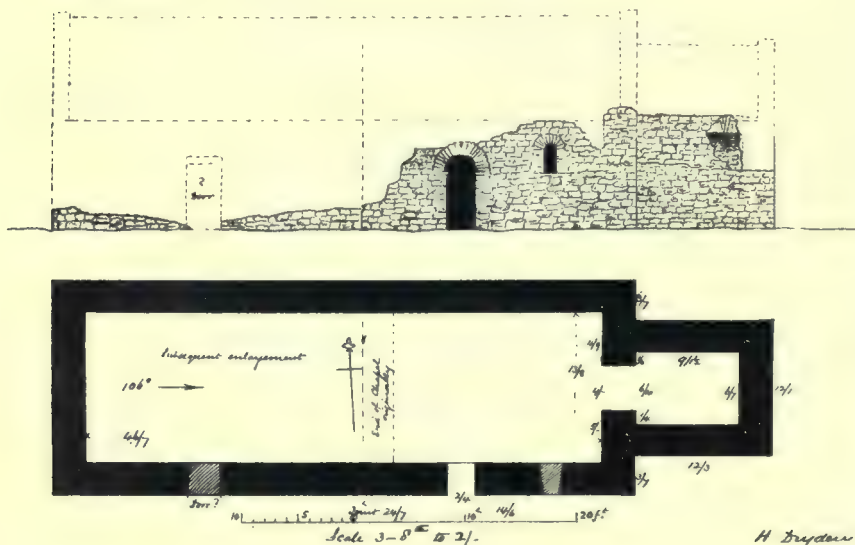
FIG. 93.—Chapel in Westray. Plan and South Elevations.

This is in the "West Graveyard," which is still used, though the chapel has been for many years a ruin. It consists of nave and chancel, and is built of the schist of the locality. It stands east and west, within two degrees. (Fig. 93.)

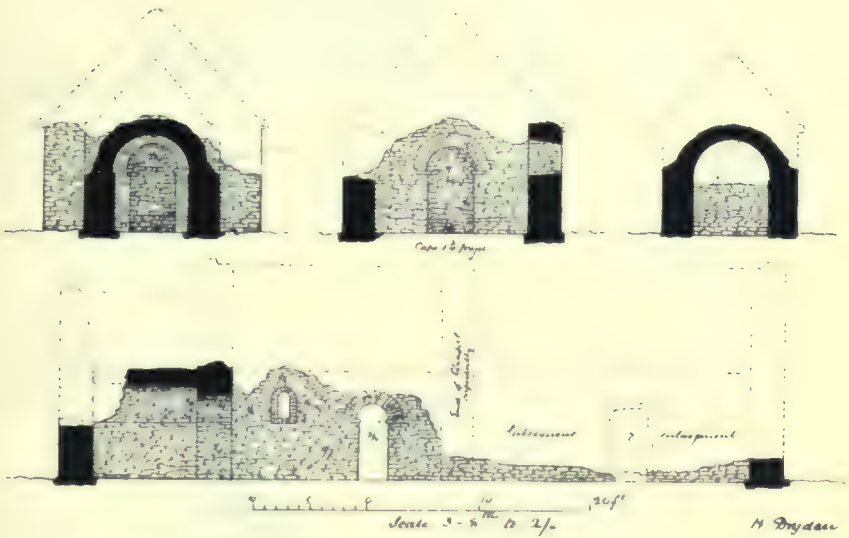
FIG. 94.—Chapel in Westray. Sections.

The chancel arch remains entire. (Fig. 94.) It has plain angular jambs 4 feet apart, a plain abacus of schist and a semicircular head.

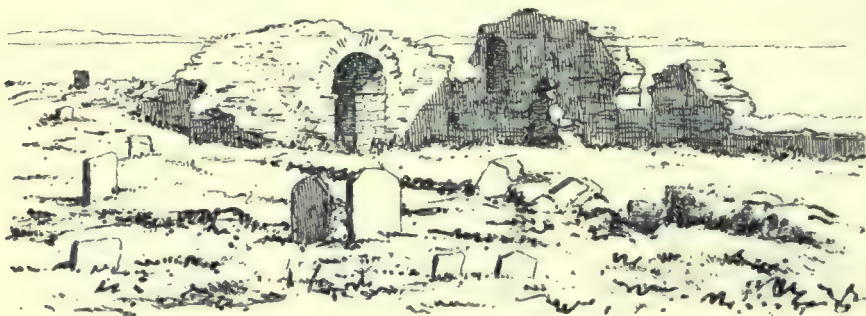
FIG. 95.—Chapel in Westray. View from North-West.

The impost is 5 feet 7 inches above what appears to be the old floor. (Fig. 95.) The wall is 2 feet 9 inches thick. The chancel is 9 feet 1 inch east and west by 6 feet 8 inches north and south inside. It had a

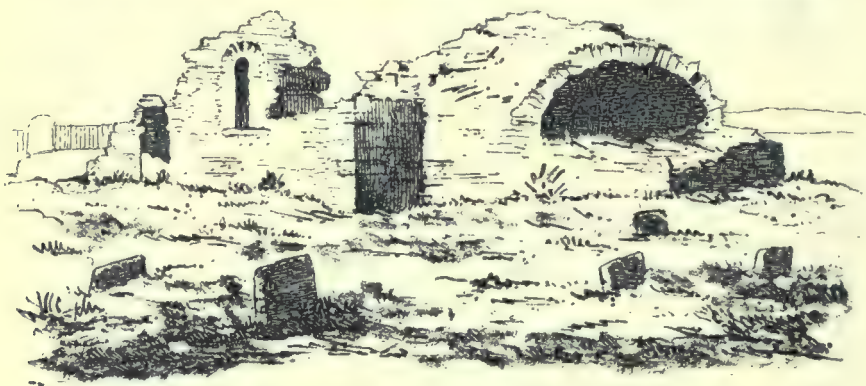
FIG. 96.—Chapel in Westray. View from South-East.

cylindrical vault, of which part remains. (Fig. 96.) It springs from the level of the impost of the chancel arch, and is slightly set back at the impost, as many of the old arches were, to give support to the centering.

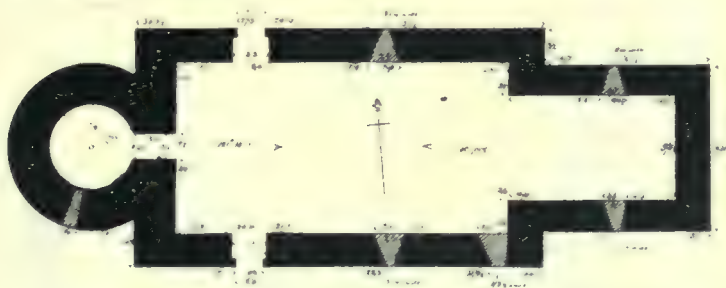
FIG. 97.—Church on Egilsey. Ground Plan.

Professor Munch infers that the Norsemen founded a church here, and called the island after it; and if this is the case, the date of the erection of the church is put very far back, unless we suppose this to be a *second* church. It was dedicated to St. Magnus; but this might be a second dedication, and probably was so. At the end of this article are further remarks on this point. The church is complete, except the roofs and the upper part of the tower, and was used up to about 18— as the place of worship. It consists of a chancel nave and tower at the west end of the nave, and stands nearly exactly east and west. (Fig. 97.)

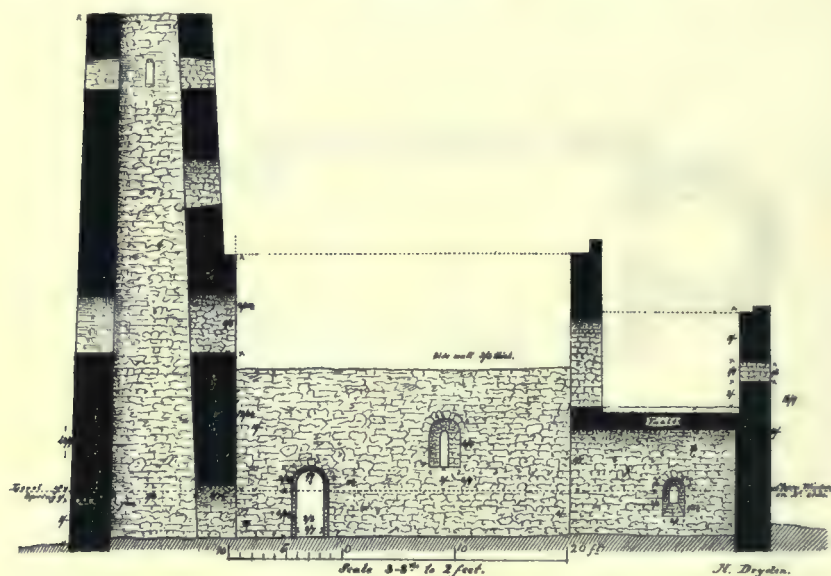
FIG. 98.—Church on Egilsey. Section from West to East.

The nave is 29 feet 9 inches by 15 feet 6 inches inside. The north and south walls are 3 feet thick. On the north and south, opposite each other, are two doorways 2 feet 6 inches wide. These have round arched
